SermaLon® delivers more off-shore

SermaLon® fouling-resistant coating improved efficiency and increased service life in a challenging deep sea environment

Improving gas compressor performance and service life

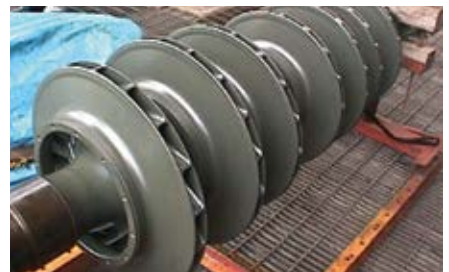
Operational effects

- 4.3% reduction in polytropic head loss after 15,000 run-hours
- Efficiency loss reduced by 61.2% after 15,000 run-hours

Coating the rotor and aerodynamic bundle with a SermaLon® fouling-resistant coat hindered deposition of corrosive products, reduced surface roughness and improved efficiency. After 15,000 run-hours, polytropic head loss was reduced by 4.3%, and overall efficiency loss was reduced from 9.8% to 3.8%. The cost of the coating was recovered in less than a year through these efficiency gains as well as a 10% reduction in fuel gas consumption. Rotor and bundle service life was extended from less than 1 year to more than 2 years, lowering downtime lost to maintenance.
